By Mark Quasius, F333630

RV A/C REPLACEMENT PROJECT

*After A Rooftop Air Conditioner
On His Motorhome Failed,
The Author Documented The
Do-It-Yourself Replacement Project
And Shares The Process Here.*

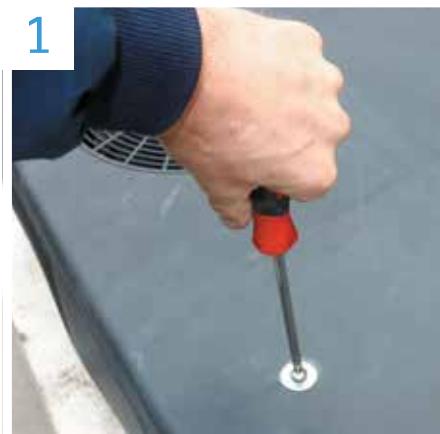
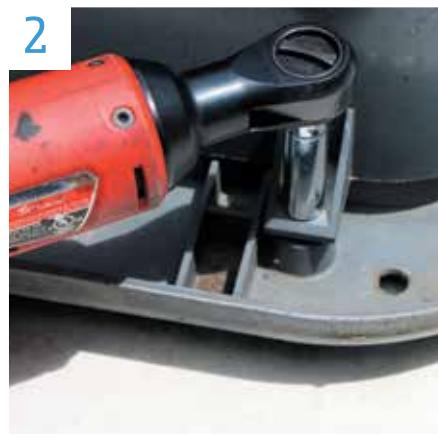
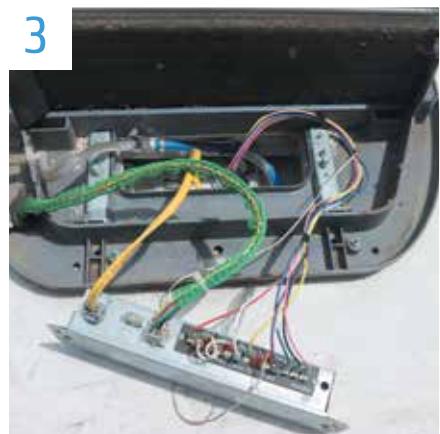
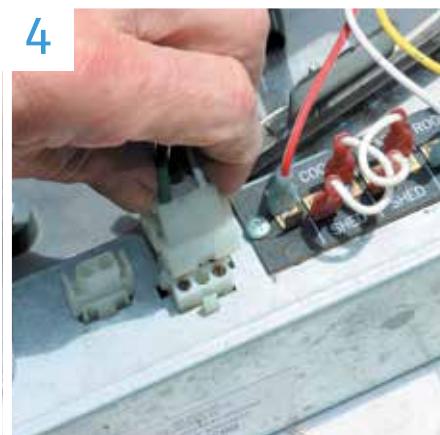
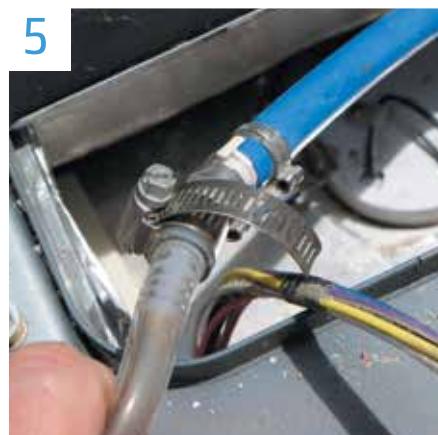
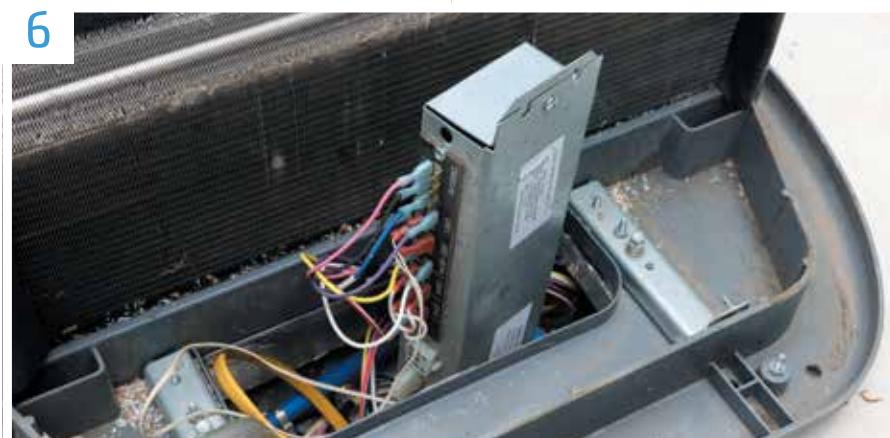
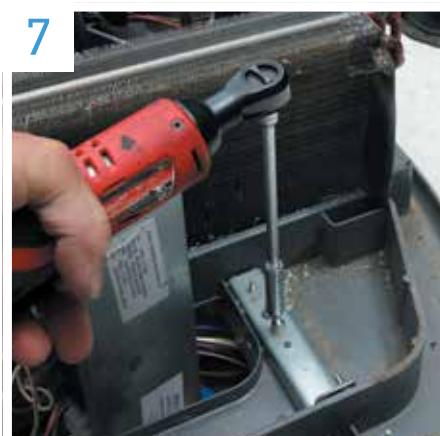
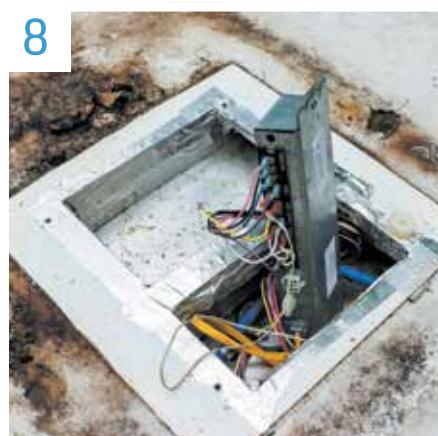
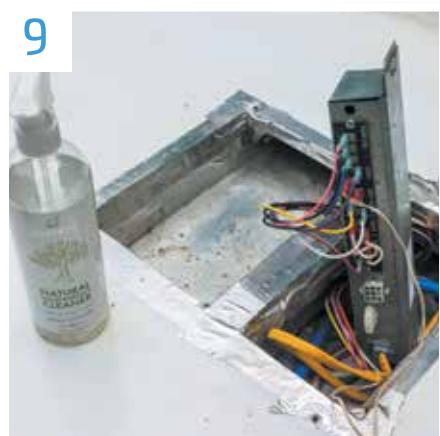
← 1) The first step was to take off the old air conditioner's top cover, held in place by four #3 Phillips-head machine screws. 2) Next, the plenum cover, secured by four $\frac{3}{8}$ -inch hex nuts, was removed. 3) Once the wing nuts that fastened the control box to the air conditioner's base were removed, the box was lifted out and set aside. 4) The air conditioner was connected to the control box via a modular plug that had to be removed to separate them. 5) A hose clamp attached the condensate drain pump to a blue PEX drain line. 6) Once disconnected from the A/C, the control box was dropped into the plenum so the A/C could be removed. 7) A cordless ratchet wrench was used to back out the long screws that secured the A/C to the aluminum tubing in the roof. 8) After the A/C was taken off, all that remained was the control box and a lot of dirt. 9) The roof after cleaning.

Taking the cover off the old unit turned out to be the easy part. Four #3 Phillips-head screws fastened it to the air conditioner, so I removed them and lifted off the cover and set it aside. That exposed most of the inner components of the air conditioner, but to get to the evaporator and electrical control box, I had to remove four 3/8-inch hex nuts that secured the fiberglass-reinforced plastic plenum cover. I easily removed the nuts using a cordless ratchet and socket and lifted off that cover.

connect the air conditioner from the control box versus disconnecting the coach wiring from the control, I decided to unplug the single AMP connector and leave the control box on the roof when removing the old air conditioner. The control box was fastened with two small wing nuts, so I removed them, unplugged the AMP connector, and lifted the control box off the air conditioner, placing it on the roof temporarily.

The air conditioner was secured to the roof using four long hex-head self-tapping screws. These screws went through designated mounting points where they threaded through the fiberglass roof, through the $\frac{3}{8}$ -inch plywood, and into the structural aluminum tubing roof trusses beneath. The screws also passed through some steel reinforcing plates to spread the clamping force across more of the air conditioner's plastic base plate. I removed these screws with the same cordless ratchet and $\frac{3}{8}$ -inch socket.

Once these screws were removed, it was time to take the air conditioner off the roof. When I lifted the unit, it made a peeling noise as the gasket released from the roof. I set the old unit off to the side and was given a view of six years of dirt, debris, and mold that were hiding beneath the air conditioner. It was pretty disgusting, so I decided to take the opportunity to clean it. Be sure to use a cleaner that is compatible with the type of roof installed on your RV.

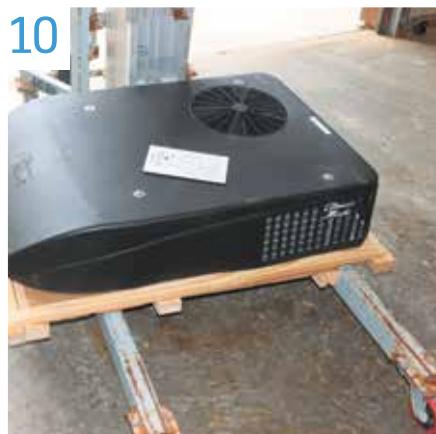
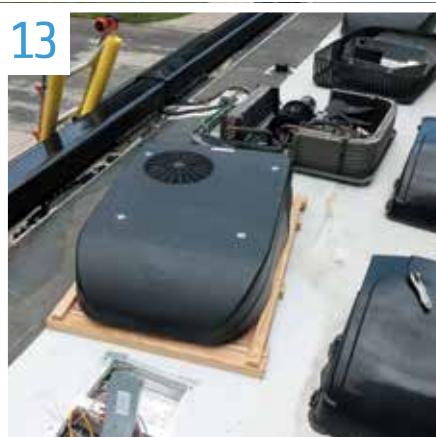
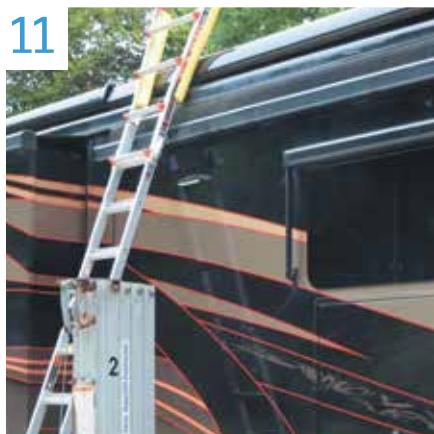
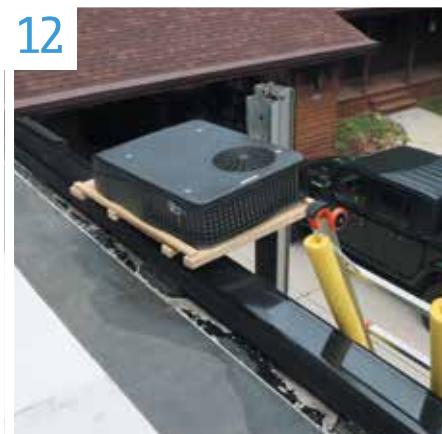
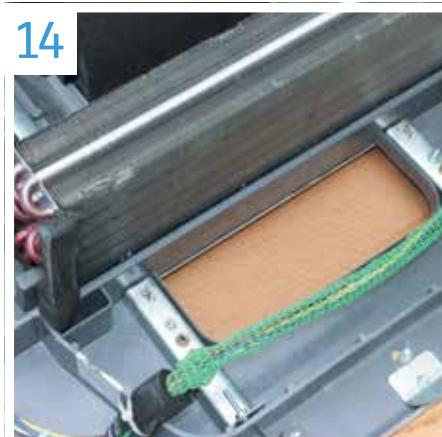
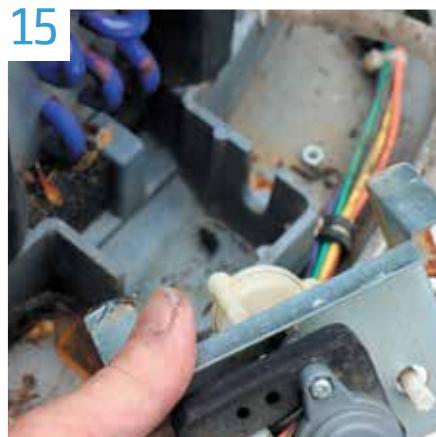
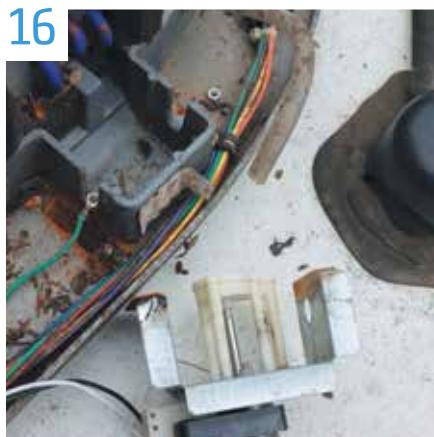
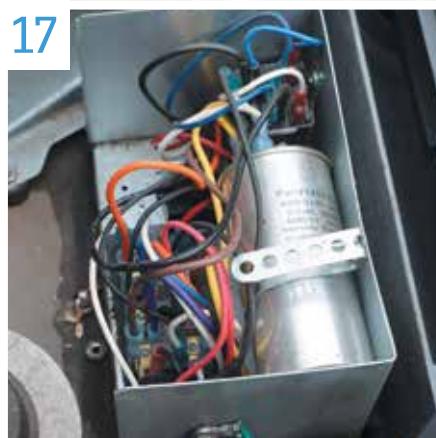
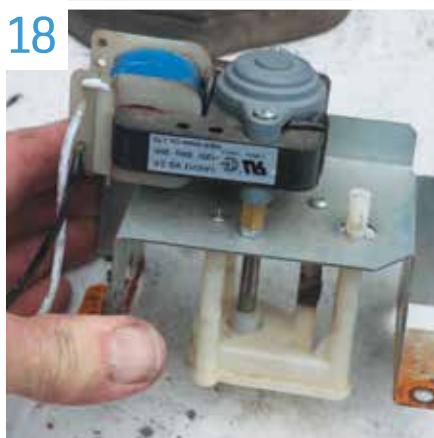
← **10)** The new air conditioner came on a wooden frame to protect the foam gasket attached to the unit's base, and the author left the frame in place while moving the unit to the roof. **11)** A rental hoist was employed to lift the A/C unit to the roof. **12) & 13)** The unit was carefully positioned over the awnings so it could be lifted off the hoist and relocated to the roof. **14)** Since the new air conditioner did not come with a condensate pump, the well for it was empty. **15)** The author repurposed the condensate pump from the old unit. **16)** With the pump removed, all that remained were the wires that ran to the connection box. **17)** The connection box contained a terminal strip where the condensate drain pump wires connected. **18)** Once removed, the pump was tested and cleaned to prepare it for the new air conditioner.

RV air conditioners are heavy. The new one is a Coleman-Mach 15,000-Btu unit with heat pumps and weighs 93 pounds. I had to figure out the logistics of getting it up onto the RV roof. I used a rental hoist designed to lift unit heaters and other materials up to commercial ceiling heights – sort of a manually operated mini forklift.

The new A/C unit was shipped on a wooden frame to protect the foam gasket on the bottom, so I left it on that structure until I was ready to position it at its new location. That also served to protect the roof surface. I kept the hoist in place, ready to receive the old unit once I removed it from its mounted location.

The second concern was that the replacement air conditioner did not come with a condensate pump; therefore, I needed to reuse the existing pump. The pump was held in place by two small hex nuts, which I removed easily. The clear discharge hose pulled right off, and I lifted the pump out of the drain well and set it aside. The two wires that powered the pump ran back to a 120-volt connection box next to the condenser fan. I removed the cover from that box, which exposed a terminal strip with several wire connections. I unplugged the two flat spade terminals on the condensate pump and removed it from the old unit. I then cleaned up the pump and tested it to make sure it worked properly before bringing it to the replacement air conditioner. Again, this setup may vary among roof-mounted A/C units.

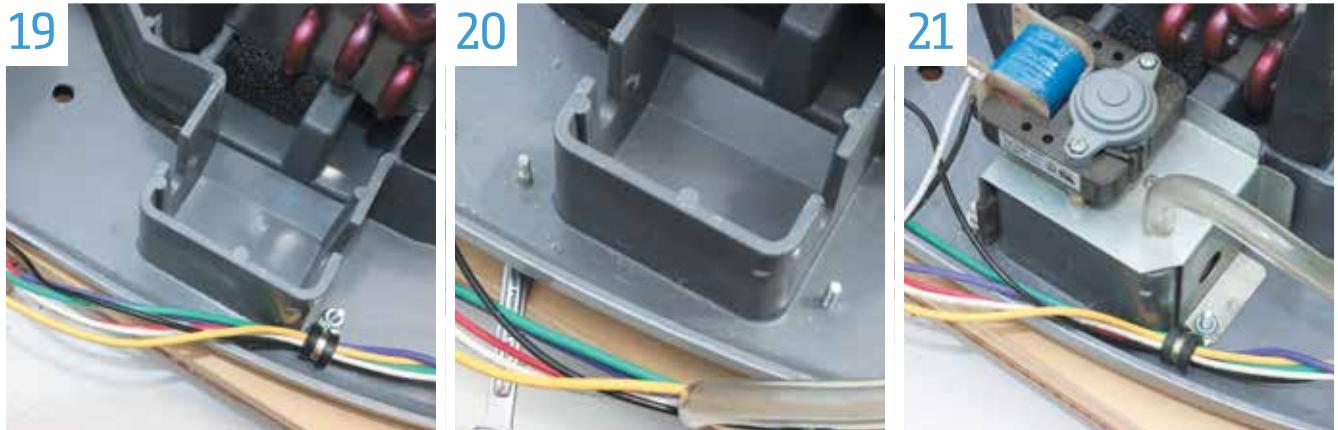
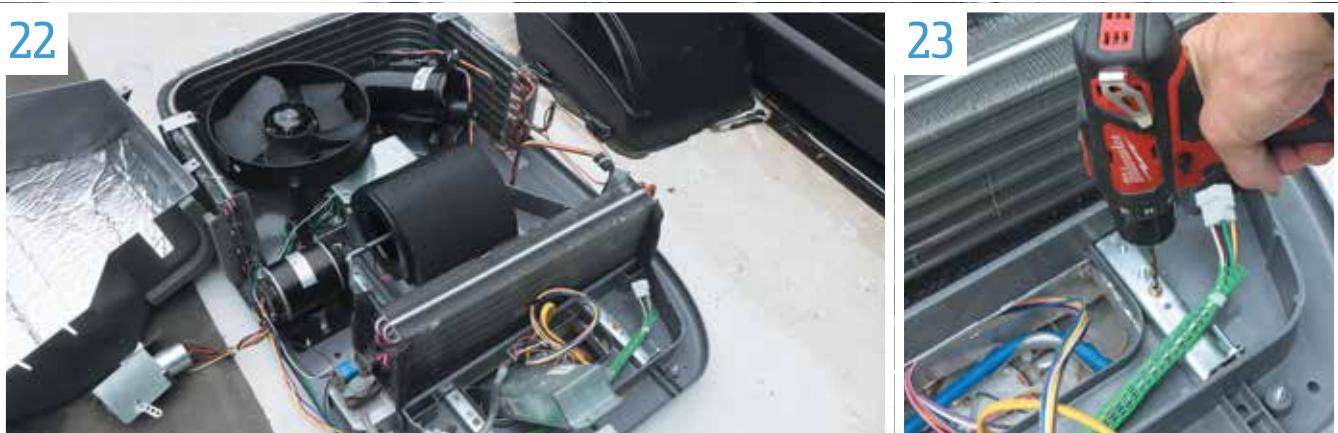
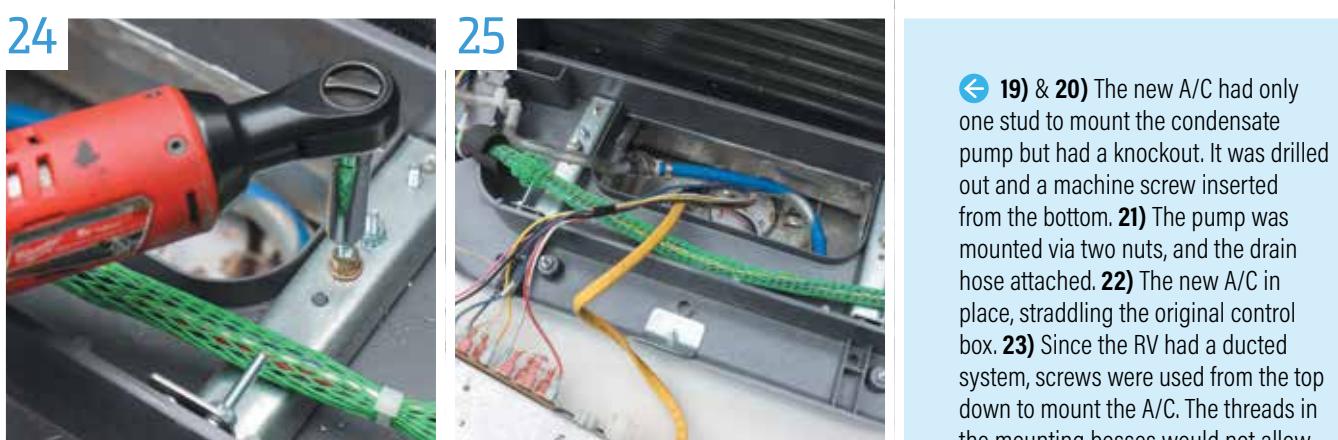
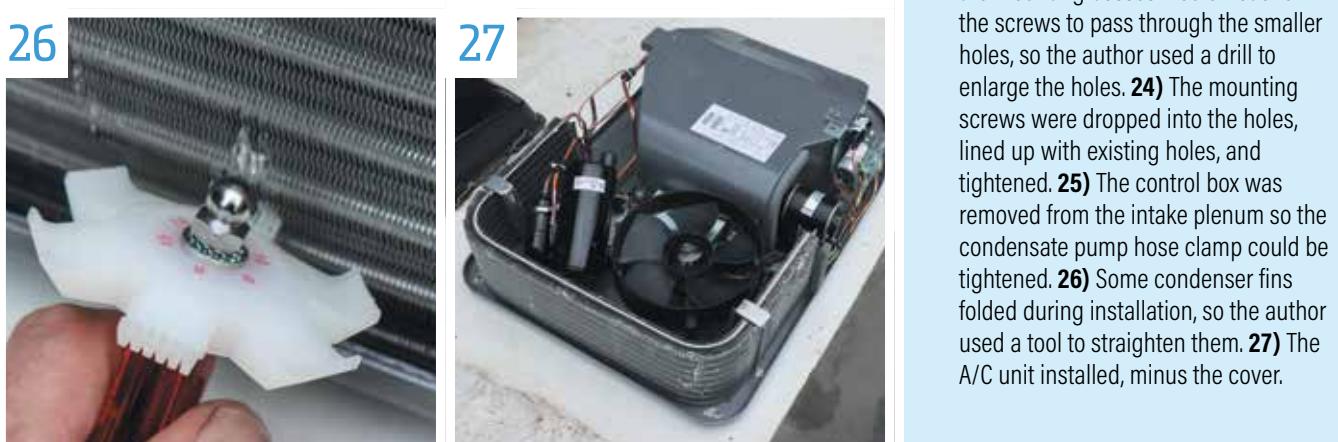
◀ **19) & 20)** The new A/C had only one stud to mount the condensate pump but had a knockout. It was drilled out and a machine screw inserted from the bottom. **21)** The pump was mounted via two nuts, and the drain hose attached. **22)** The new A/C in place, straddling the original control box. **23)** Since the RV had a ducted system, screws were used from the top down to mount the A/C. The threads in the mounting bosses would not allow the screws to pass through the smaller holes, so the author used a drill to enlarge the holes. **24)** The mounting screws were dropped into the holes, lined up with existing holes, and tightened. **25)** The control box was removed from the intake plenum so the condensate pump hose clamp could be tightened. **26)** Some condenser fins folded during installation, so the author used a tool to straighten them. **27)** The A/C unit installed, minus the cover.

had a thicker reinforced area with a dimple where the second stud would be, so I just drilled it out and mounted a machine screw in it to accept the pump bracket's second mounting hole. I then dropped the pump into place, fastened it with two nuts, and attached the drain hose. Next, I ran the two wires back to the connection box. When I opened the box, I found that this revision had a different terminal strip arrangement than the old one. Fortunately, a wiring schematic was printed inside the cover, which showed me where to connect the two wires to the condensate pump.

Some of the fins on the condenser were slightly folded over, which tends to happen when removing covers and

handling units like this. Unless the damage is excessive, this doesn't make a large difference in cooling capacity, so I could have left the fins alone. But I get a bit picky and ended up using my radiator fin comb to straighten them out.

Next, I reconnected the condensate pump's clear drain hose to the blue PEX line and tightened the worm-drive clamp. The wiring harness was coupled to the electric control box's AMP connection terminal, and I tucked the excess wire into the plenum and remounted the control box using the original wing nuts. The freeze sensor probe was then tucked into fins in the evaporator coil.
